Summary

Sova Inspection Group
703-239-7682
David@sovainspectiongroup.com

Customer
Blue Box Auction

Address
4210 Cornland Rd
Chesapeake VA 23322

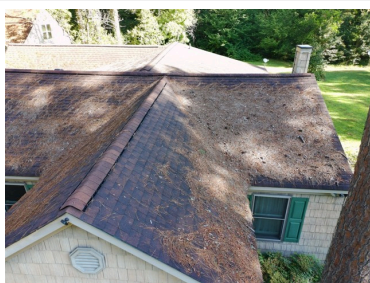
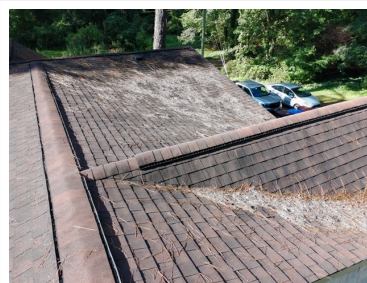
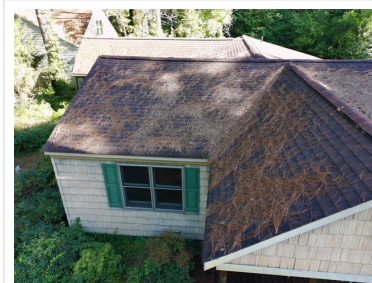
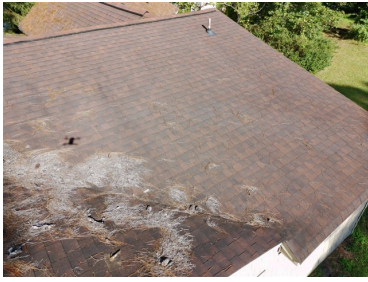
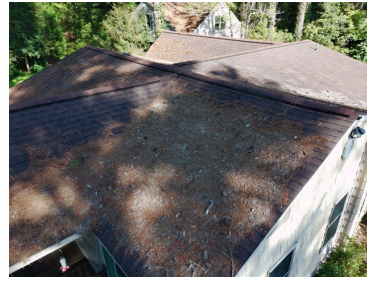
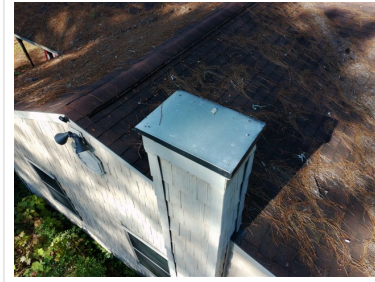
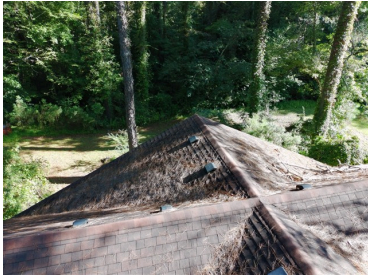
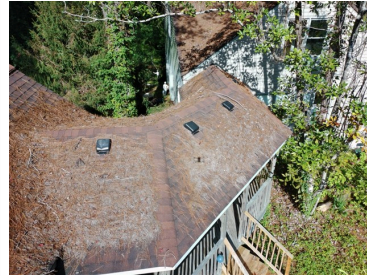
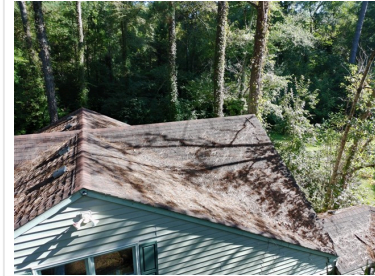
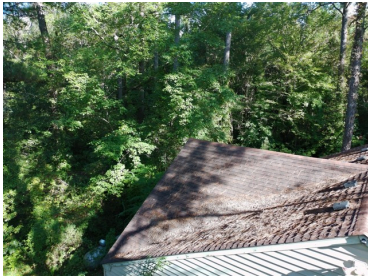
(1) Informational view of roof covering and roof penetrations. I recommend having a qualified contractor remove roof debris to ensure efficient function -

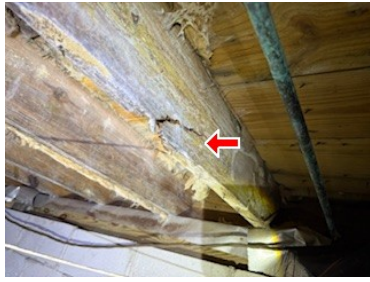
(3) WDO, wood destroying organisms and damage noted (fungus), crawl space may need to be treated; have a qualified moisture contractor evaluate for treatment. Repair any associated damage as recommended.

5.0 Item 4 (Picture)
WDO

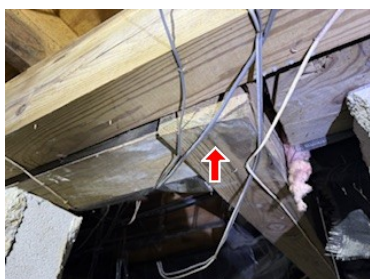
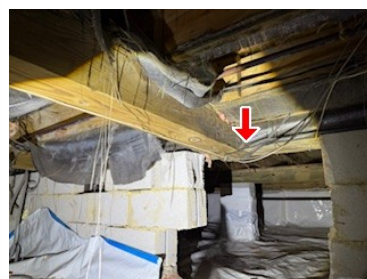
(4) Unsupported beam was noted, but not limited to rear of crawl space. Have a licensed, qualified contractor evaluate and properly repair as necessary to ensure adequate, long term footed support is in place

5.0 Item 12 (Picture)
Rear of crawl

5.0 Item 13 (Picture)
Rear of crawl

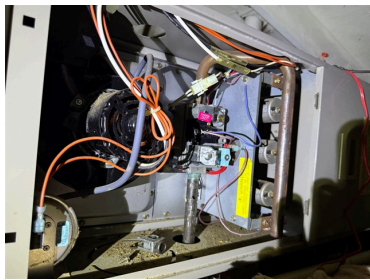
Gas furnace is estimated to be 20 years old. Recommend unit be serviced and the heat exchangers be evaluated by a licensed HVAC contractor for cracks/ holes, and replaced if needed – or CERTIFIED there are not cracks, holes or damage and that it is safe to use.

8.0 Item 1 (Picture)
Furnace burner area
