INSPECTION REPORT  
4210 Cornland Rd  
Chesapeake VA 23322

INSPECTED BY  
David Rapoport  
Sova Inspection  
Group  
Va-3380000962  
Exp-6/30/2027

INSPECTION DATE  
📅 9/25/2025  
🕒 09:00 AM

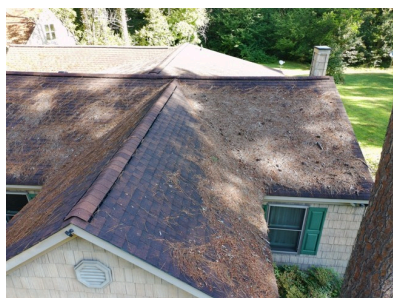
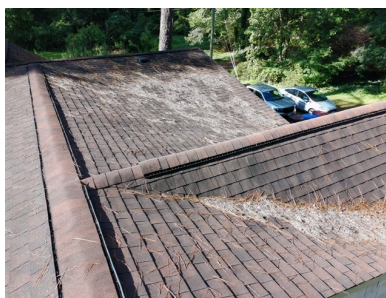
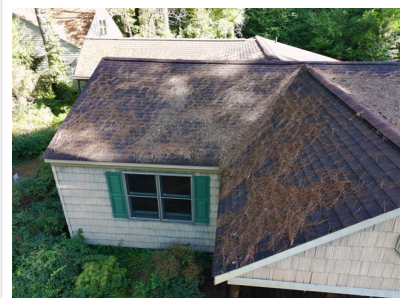
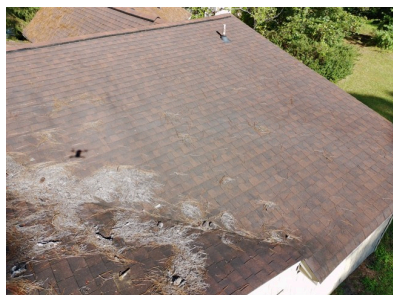
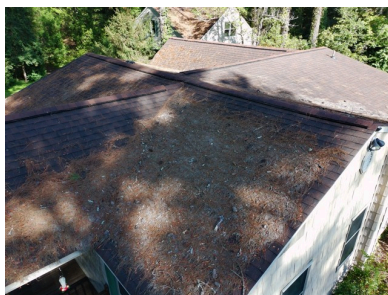
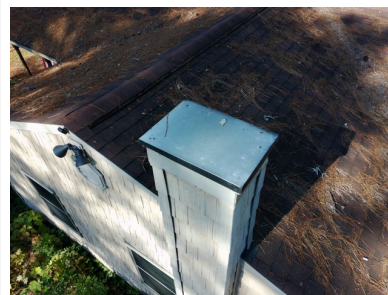
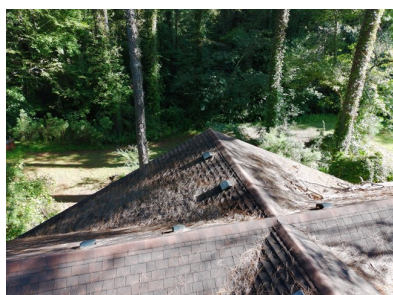
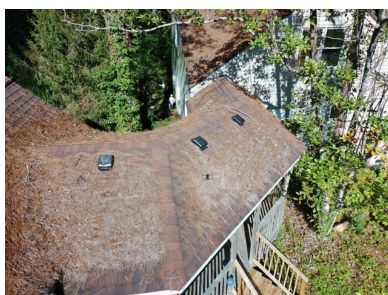
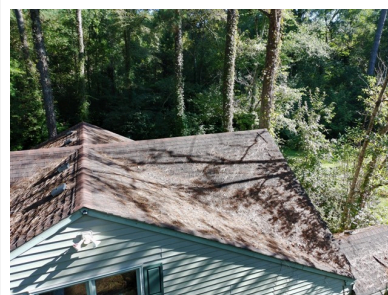
(1) Informational view of roof covering and roof penetrations. I recommend having a qualified contractor remove roof debris to ensure efficient function -

**1.0 Item 1 (Picture)**  
View of roof

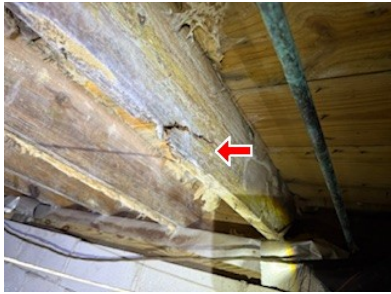
(3) WDO, wood destroying organisms and damage noted (fungus), crawl space may need to be treated; have a qualified moisture contractor evaluate for treatment. Repair any associated damage as recommended.

5.0 Item 4 (Picture)  
WDO

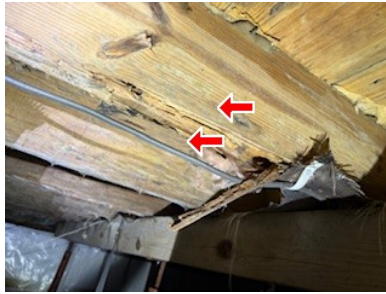
5.0 Item 5 (Picture)  
WDO

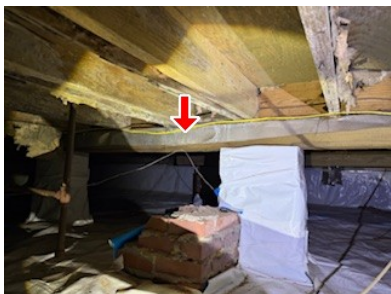
5.0 Item 7 (Picture)  
WDO

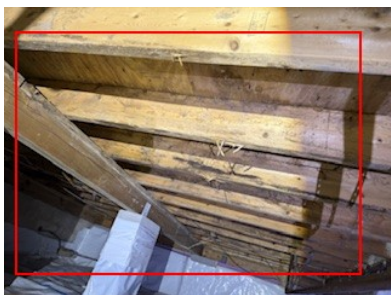
5.0 Item 10 (Picture)  
WDO

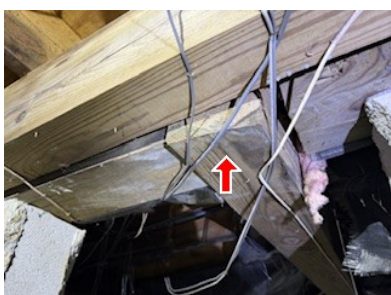
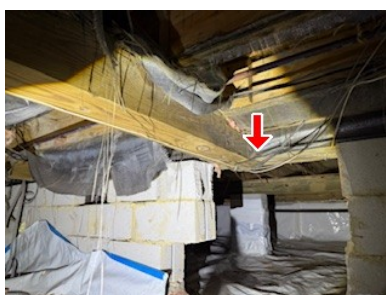
(4) Unsupported beam was noted, but not limited to rear of crawl space. Have a licensed, qualified contractor evaluate and properly repair as necessary to ensure adequate, long term footed support is in place

5.0 Item 12 (Picture)  
Rear of crawl

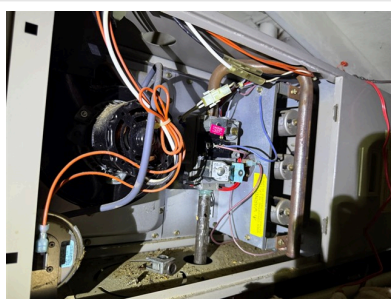
Gas furnace is estimated to be 20 years old. Recommend unit be serviced and the heat exchangers be evaluated by a licensed HVAC contractor for cracks/ holes, and replaced if needed - or CERTIFIED there are not cracks, holes or damage and that it is safe to use.

**8.0 Item 1 (Picture)**  
Furnace burner area
